FAILURE ANALYSIS OF THREE SLOW SPEED INDUCTION MOTORS FOR RECIPROCATING LOAD APPLICATION

Copyright Material IEEE
Paper No. PCIC-2005-XX

Abstract - This refinery has three 5400 HP slow speed induction motors driving reciprocating compressors for a Hydrogen plant. All motors were rewound on site over a period 1998-2002 using magnetic wedges as per the original design and the motor protection was upgraded to microprocessor type relays. In summer 2003 it was noted that the motors suffered substantial loss of slot magnetic wedges and had to be scheduled for re-wedging over 2004-2005. The paper presents failure analysis, field measurements covering heat run test results, motor performance and vibration analysis before and after motor re-wedging work. The paper reviews the key factors for using magnetic versus non-magnetic wedges in these applications and techniques available to predict loss of wedges. The use of a microprocessor relay for slow speed induction motors protection is discussed particularly the thermal protection feature to address the cyclic load pattern caused by the reciprocating compressor.

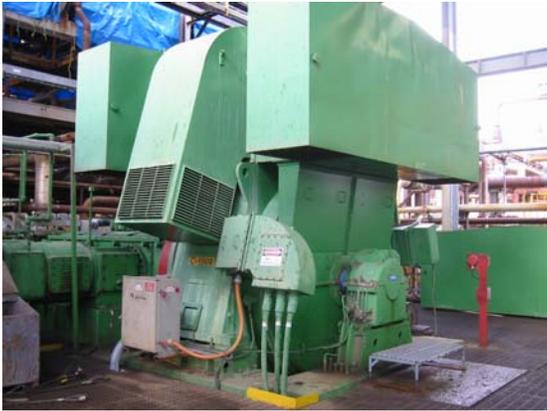
However, magnetic wedges are more brittle than non-magnetic due to high percentage of iron powder in the magnetic wedge. In summer 2003 a routine inspection of C1904 revealed debris of packing and magnetic wedge material inside the stator. An investigation was undertaken to look into the premature loss of wedges and impact on the motor performance. The original motor manufacturer was consulted to review this situation as well as to determine any available measuring techniques in predicting loss of wedges without physically dismantling the motor. These motors are located in class I, division II, group B and D areas and the compressor shelter is open on all four sides. Fig. 1 shows a motor overview.

Fig. 1. 5400 HP Motor overview.

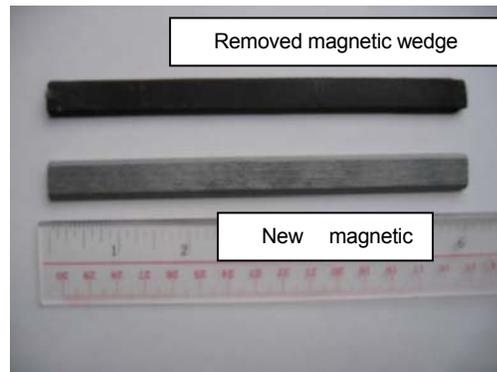
The data sheet for replacement magnetic wedge material and epoxy resin was reviewed and approved by the original motor manufacturer to be used for re-wedging work. Fig. 2 shows a sample of removed and replacement magnetic wedges. Overall length of each magnetic wedge strip is 6". The epoxy was mixed in smaller quantities to maintain its light viscosity and then applied using a brush.

Fig. 2. Samples of new and removed magnetic wedges. Each wedge is 6" long by 9/16" wide by 0.15" deep.

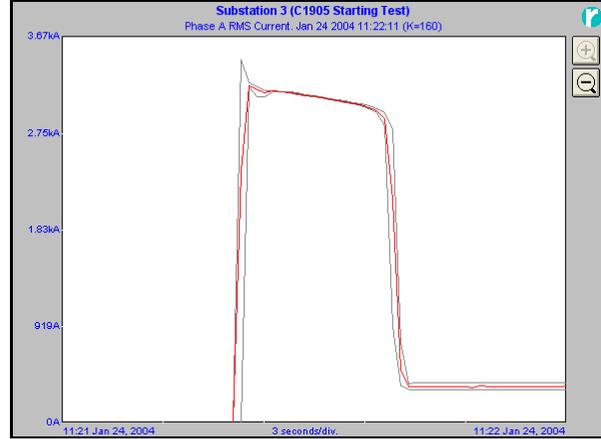
Prior to re-wedging the motor was started three times to record inrush current and vibration. Fig. 4A and 4B show the starting current and voltage profile. Acceleration time was measured at 5 seconds. Starting voltage drop was 17.5% measured at 4.16 KV bus. Starting current was 3219 A. The starting current corrected to rated voltage is calculated as follows:

The measured inrush current is about 7.4% higher than nameplate value.

Fig. 4A. Starting current profile for 5400 HP motor prior to re-wedging and measured at 3129A and 5 seconds acceleration time.

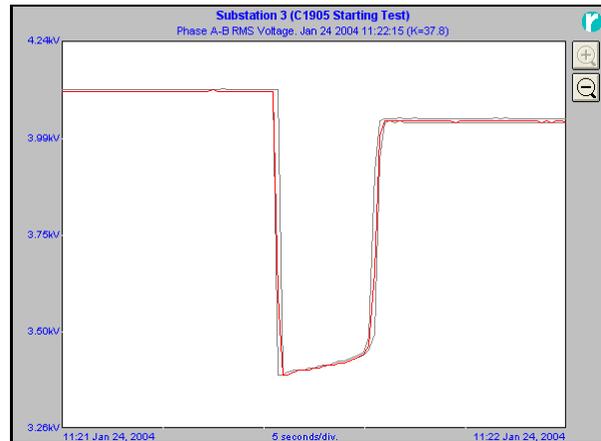
Fig. 4B. Motor terminal voltage profile during starting and it dropped from 4118 V to 3390 V or by 17.5%.

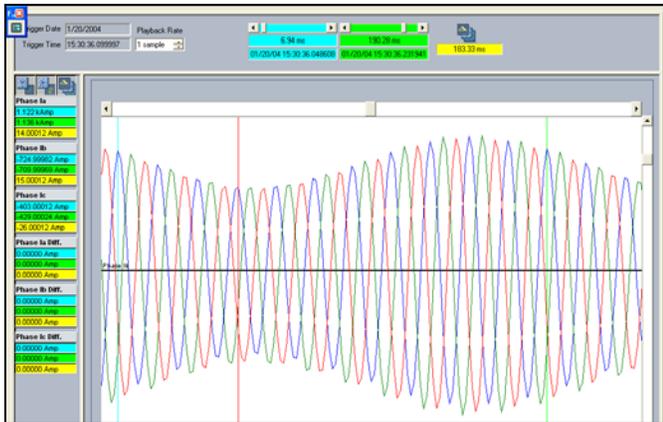
Fig. 3 shows the motor load profile for C1905, which is cyclic and the pattern repeats itself almost every 11 cycles. The motor has 22 poles and rated speed is 325 rpm. Number of revolution per second = $325/60 = 5.4167$. For every one motor revolution, there are $60/5.4167 = 11.07$ cycles. Maximum measured peak current was 1259 A and minimum was 782 A. It is recommended [3] that current pulsation should not exceed 66% of full load current. In this case, current pulsation is = $(1259 - 782) \times 100 / 740 \times 1.414 = 46\%$ and this is within the acceptable limits. Similar motor load profile measurements were recorded for C1904 and C1906 and results were identical to that of C1905 and less than 66% of full load current.

Fig. 3. Three phase motor current profile for reciprocating compressor at 100% load. Profile is cyclic and repeats itself every 11.07 cycles. Maximum amplitude is 1259 A and minimum is 782 A.

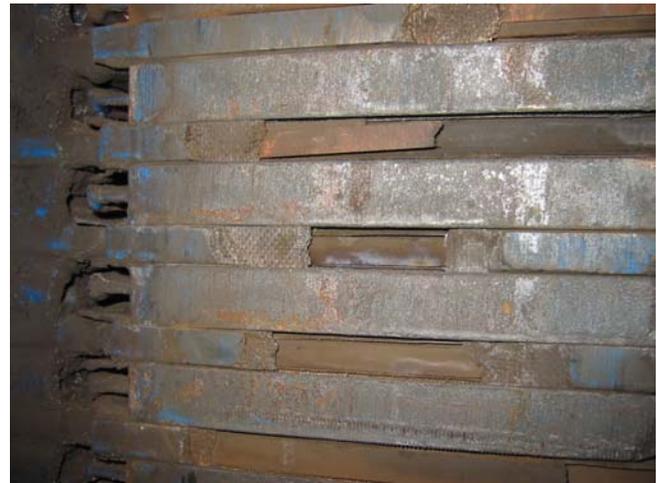
Following these tests, the motor was released for dismantling and removing the rotor. Fig. 5 shows an enlarged view of the stator winding as found. Careful examination of stator winding revealed the following:

- Almost over 50% of the magnetic wedges and packing were missing. The stator has 198 slots and each slot length requires 6 wedges. Total number of wedges is $6 \times 198 = 1188$.
- Loss of wedges was sporadic but more wedges were missing in centre part of the core.
- Air ducts were reasonably clean and no visible blockage.
- Signs of corrosion at scattered areas in the core.
- There was no visible sign of any coil or end winding movement in the slot in spite of many missing wedges. The end winding were secured using blocking.
- There was no sign of any coil insulation wrapping discoloration.
- Some sign of rotor rubbing against the stator, which probably happened when pulling the rotor out.
- Some stator laminations were damaged.
- There was some sign of salt particularly closer to end winding. The source of salt is probably due to the refinery proximity to sea.

Fig. 5. Enlarged area for C1905 motor showing several partially or completely missing magnetic wedges from stator slots.

The C1905 motor was cleaned and all magnetic wedges removed. A core loss test was conducted using 3-phase 600 V portable generator to supply the required voltage and current. There were very few hot spot areas noted and were corrected by separating the lamination using a mallet. A coat of epoxy resin was first applied with a brush in the slot before fitting the wedges, magnetic wedges were driven into position one by one, and then a second coat of epoxy resin was applied to fill in any voids and to prevent movement of wedges. The process of fitting the new magnetic wedges took about 48 hours with two service technicians working, one at each end. The motor was assembled and underwent more testing that included measuring inrush current and vibration. The results showed that there was hardly any change in magnitude of inrush current before and after re-wedging. Prior to re-wedging the inrush current was measured at 5.37 PU and after re-wedging it was 5.22 PU, or about 4% drop.

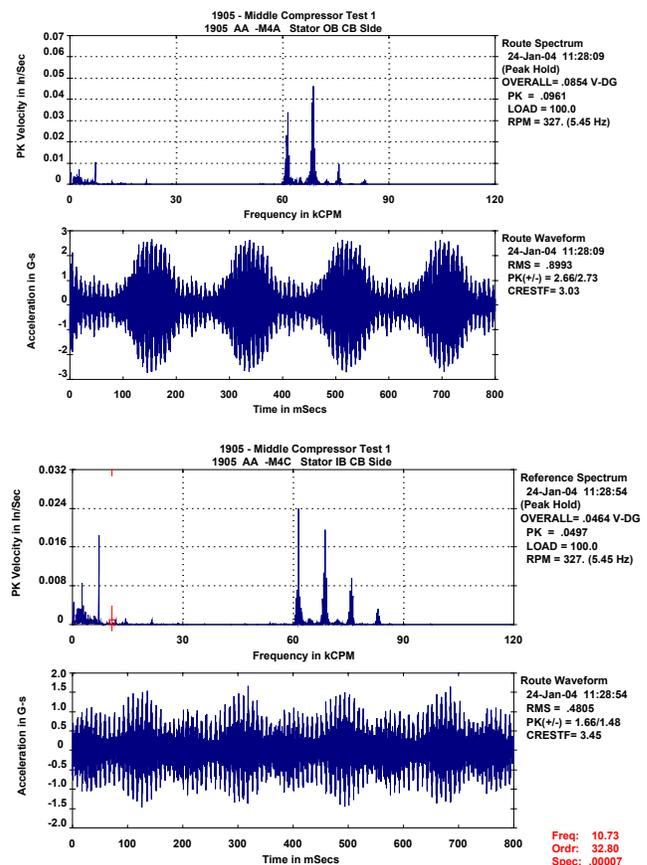
Analyzing the vibration spectrums during motor startup, at no load and full load operation, revealed that there is a high frequency vibration originating from the stator core, which is commonly known as slot tooth pass frequency/harmonics. The reciprocating compressor to which the motor is coupled creates a fluctuating load, which causes the speed of the motor (angular velocity) to vary. This variation in motor current, speed and magnetic field causes the fluctuating and varying vibration in the stator teeth between 60,000 and 70,000 CPM (cycles per minute). In addition, the fundamental 60 Hz frequency in the stator causes the magnetic wedges to vibrate at the fundamental frequency. These fluctuating vibrations will cause the magnetic wedges to breakdown prematurely, because of the

high iron content of the wedge and its poor mechanical properties. In addition, the salt in the atmosphere caused corrosion of the stator laminations and magnetic wedges compounding the problem.

Fig. 6 and 7 show vibration of the motor with approximately 50% of the magnetic wedges missing. Fig. 8 shows vibration spectrum on stator core with motor unloaded, after rewedging. The vibration spectrums are the same before and after rewedging. It can be seen that the amplitude of the high frequency vibrations exceeds the amplitude of the low frequency vibrations. This is not common and is an indication of high flux densities in the stator core.

Fig. 6. Vibration spectrum of the stator core taken at 9 and 12 O'clock positions, before rewedging with about 50% of the magnetic wedges missing. The reciprocating load is reflected in the time waveform signature.

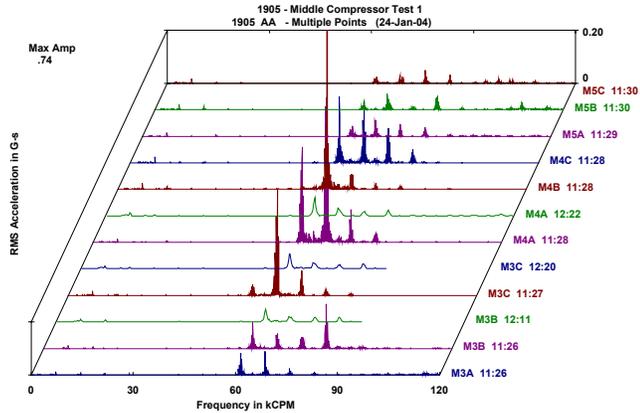
Fig. 7. Cascade plot of the vibration spectrum prior to rewedging. The cycling nature of the compressor is directly reflected in the vibration spectrums over time.

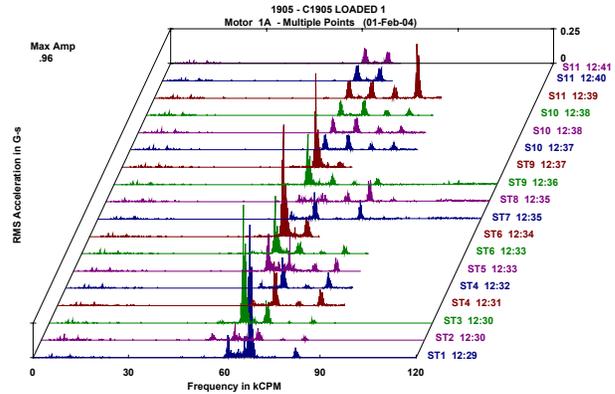
Fig. 9 and 10 show vibration of the motor after rewedging, loaded. As the motor went from no-load to full load, the severity of the high frequency vibration increased by 4 to 5 times. This high frequency vibration is not uncommon, but on a well-designed motor, the amplitude of the high frequency is very low or non-existent.

Fig. 10. Cascade of vibration spectrum on the stator core, when the motor is loaded. No change in vibration exhibited on the stator core even after re-wedge.

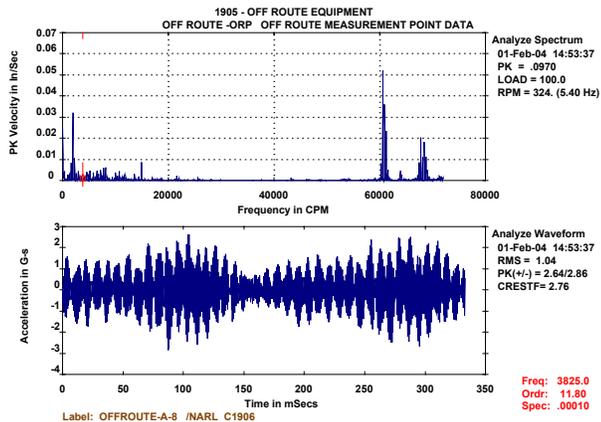
Fig. 8. Vibration spectrum on stator core, unloaded, after rewedging.

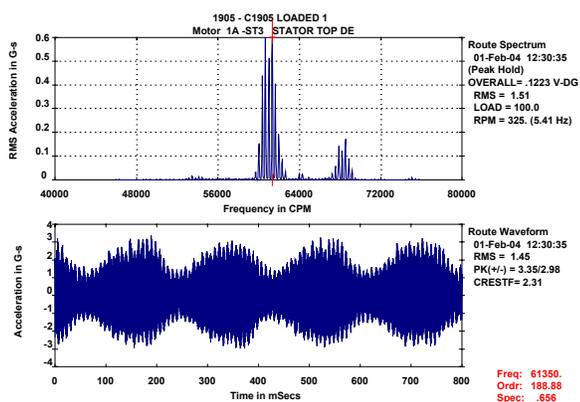
Fig. 9. Vibration spectrum on stator core, loaded, after rewedging. Vibration cycling is still very predominating.
