Failure Analysis of Three Slow-Speed Induction Motors for Reciprocating Load Application

Abstract—The North Atlantic Refinery has three 5400-hp slow-speed induction motors driving reciprocating compressors for a Hydrogen plant. All motors were rewound on-site over the period of 1998–2002, using magnetic wedges as per the original design, and the motor protection was upgraded to microprocessor-type relays. In summer 2003, during routine maintenance, it was noted that these motors suffered substantial loss of slot magnetic wedges and had to be scheduled for rewedging over 2004–2006. This paper presents failure analysis, field measurements covering heat-run test results, and motor-performance and vibration analysis before and after motor rewedging work. This paper reviews the key factors for using magnetic versus nonmagnetic wedges in these applications and techniques available to predict loss of wedges. The use of a microprocessor relay for slow-speed induction motor protection is discussed, particularly, the thermal protection feature to address the cyclic-load pattern caused by the reciprocating compressor.

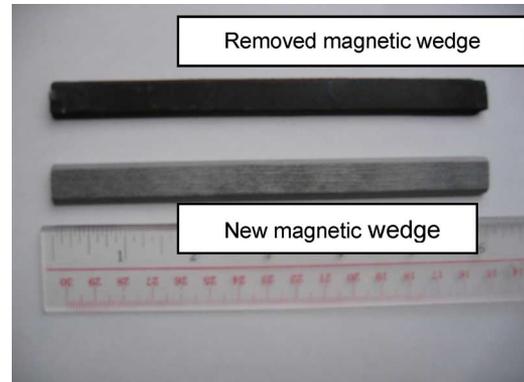
Fig. 2. Samples of new and removed magnetic wedges. Each wedge is 6-in long by 9/16-in wide by 0.15-in deep.

There are several factors that impact the reliability and longevity of magnetic wedges particularly for this refinery application. The load is of the reciprocating type and the magnetic wedges are, therefore, subjected to cyclic mechanical forces (120 times per second). If there is any freedom to move, fretting will occur and the movement will slowly increase resulting in wedge disintegrating. The problem for this refinery was compounded due to the following reasons.

- 1) During motor rewinding in 1998–2002, magnetic wedges were not epoxyed and a dry process was used (instead of the recommended wet).
- 2) Vacuum-pressure-impregnation process has not been used, because stator rewinding was done on-site. Also, due to the large diameter of the stator core, there are no local motor repair shops that can perform this work.
- 3) Motors are required to run slightly above rated load to meet process demand.
- 4) Motors are started on average every two weeks due to mechanical and process conditions. This frequent start subjects the stator and rotor core to thermal cycling as well as the transient vibration.

The technical data sheet for replacement magnetic wedge material and epoxy resin was reviewed and approved by the original motor manufacturer to be used for rewedging work. Fig. 2 shows a sample of removed and replacement magnetic wedges. Overall length of each magnetic wedge strip is 6 in. The epoxy was mixed in smaller quantities to maintain its light viscosity and then applied using a brush.

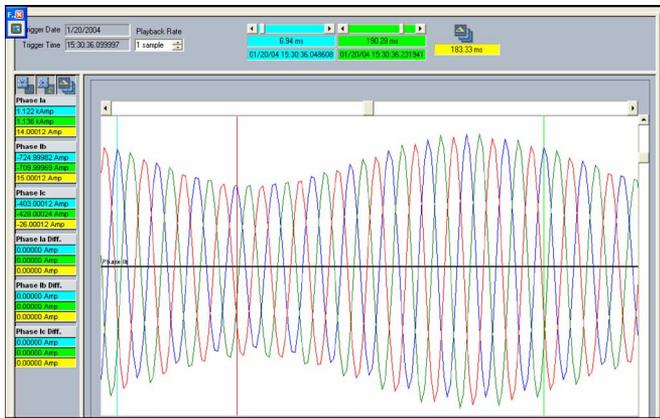
Fig. 3. Three-phase motor current profile for reciprocating compressor at 100% load. Profile is cyclic and repeats itself every 11.07 cycles. Maximum amplitude is 1259 A and minimum is 782 A.

Fig. 3 shows the motor-load profile for C1905, which is cyclic and the pattern repeats itself almost every 11 cycles. The motor has 22 poles and rated speed is 325 r/min. Number of revolution per second = $325/60 = 5.4167$. For every one motor revolution, there are $60/5.4167 = 11.07$ cycles. Maximum measured peak current was 1259 A and the minimum was 782 A. It is recommended [4] that current pulsation should not exceed 66% of full-load current. In this case, current pulsation is $= (1259 - 782) \times 100/740 \times 1.414 = 46\%$ and this is within the acceptable limits. Similar motor-load-profile measurements were recorded for C1904 and C1906, and results were identical to that of C1905 and less than 66% of full-load current.

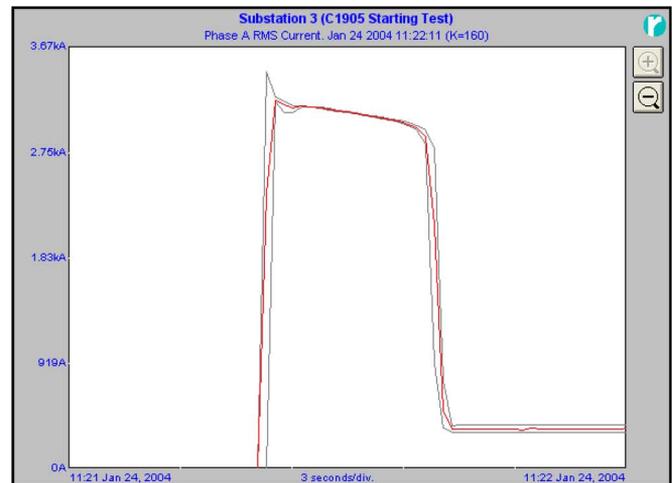
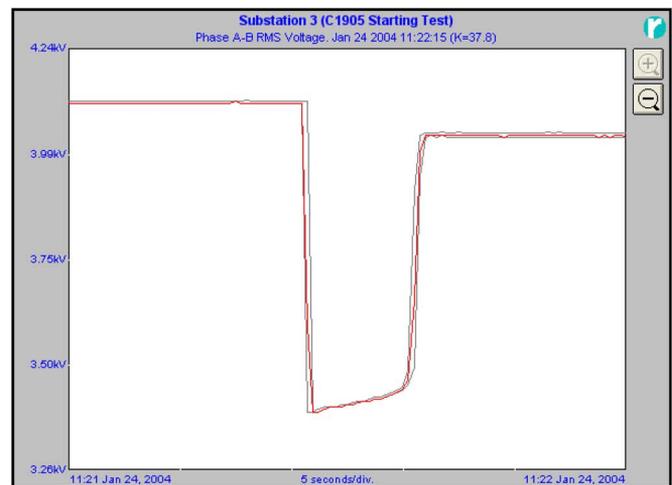
Prior to rewedging of C1905, it was started three times to record inrush current and vibration. Fig. 4(a) and (b) shows the starting current and voltage profile. Acceleration time was measured at 5 s. Starting voltage drop was 17.5% measured at 4.16-kV bus. Starting current was 3219 A. The starting current corrected to rated voltage is calculated as follows.

$$\begin{aligned} \text{Starting current at V rated} &= \text{measured starting current}/(\text{reduced voltage})^{1.1} \\ &= 3219/(0.825)^{1.1} \\ &= 3977 \text{ A.} \\ \text{Rated current} &= 740 \text{ A.} \\ \text{Starting current } 3977/740 &= 5.37 \text{ PU.} \end{aligned}$$

The motor nameplate shows that the starting current is 5 PU. The measured inrush current is about 7.4% higher than nameplate value.

Fig. 4. (a) Starting current profile for 5400-hp motor prior to rewedging and measured at 3129 A and 5-s acceleration time. (b) Motor terminal voltage profile during starting and it dropped from 4118 to 3390 V or by 17.5%.

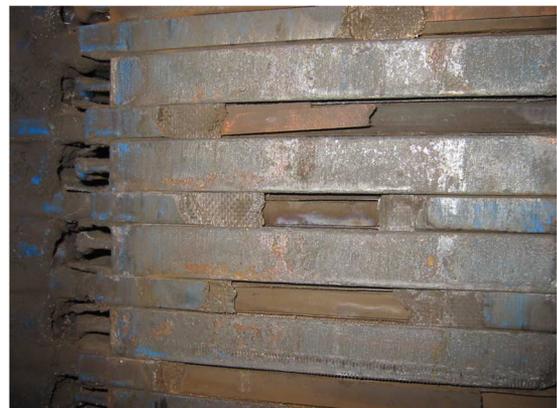
Following these tests, the motor was released for dismantling and for removal of the rotor. Fig. 5 shows an enlarged view of the stator winding as found. Careful inspection of C1905 stator winding revealed the following.

- 1) About 50% of the magnetic wedges and packing were missing. The stator has 198 slots and each slot length requires six wedges. Total number of wedges is $6 \times 198 = 1188$.

Fig. 5. Enlarged area for C1905 motor showing several partially or completely missing magnetic wedges from stator slots.

- 2) Loss of wedges was sporadic but noted that more wedges were missing in the center part of the core.
- 3) Air ducts were reasonably clean and no visible blockage.

- 4) There were some signs of corrosion at scattered areas in the core.
- 5) There was no visible sign of any coil- or end-winding movement in the slot in spite of too many missing wedges. This is because the end winding were secured using blocking.
- 6) There was no sign of any coil-insulation-wrapping discoloration.
- 7) There was some sign of rotor rubbing against the stator, which probably happened during the rotor removal.
- 8) Some stator laminations were damaged.
- 9) There was some sign of salt, particularly closer to end winding. The source of salt is probably due to the refinery proximity to sea.

The C1905 motor was cleaned and all magnetic wedges removed. A core-loss test was conducted using three-phase 600-V portable generator to supply the required voltage and current. There were very few hot-spot areas noted and were corrected by separating the lamination using a mallet. A coat of epoxy resin was first applied with a brush in the slot before fitting the wedges. Magnetic wedges were driven into position one piece at a time, and then, a second coat of epoxy resin was applied to fill in any voids and to prevent movement of wedges. The process of fitting the new magnetic wedges took about 48 h with two service technicians working, one at each end. The motor was assembled and underwent more testing that included measuring inrush current and vibration. The results showed that there was hardly any change in magnitude of inrush current before and after rewedging. Prior to rewedging the inrush current was measured at 5.37 PU and after rewedging it was 5.22 PU, or about 4% drop. C1905 was placed in service in the end of January 2004.

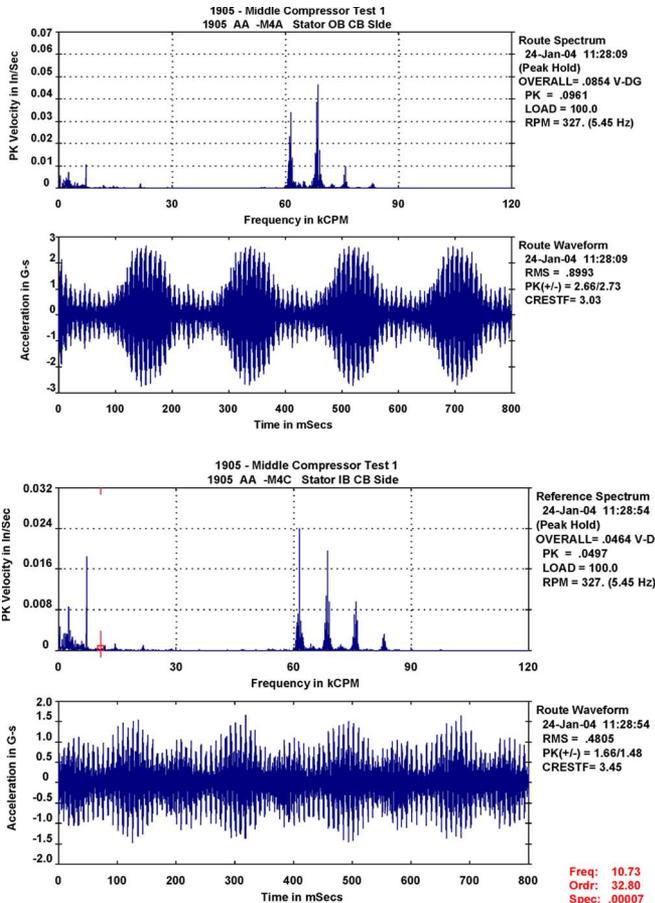
Figs. 6 and 7 show vibration of the motor with approximately 50% of the magnetic wedges missing. Fig. 8 shows the vibration spectrum on stator core with motor unloaded after rewedging. The vibration spectrums are the same before and after rewedging. It is shown that the amplitude of the high-frequency vibrations exceeds the amplitude of the low-frequency vibrations. This is not common and is an indication of high flux densities in the stator core.

Fig. 6. Vibration spectrum of the stator core taken at 9 and 12 o'clock positions, before rewedging with about 50% of the magnetic wedges missing. The reciprocating load is reflected in the time waveform signature.

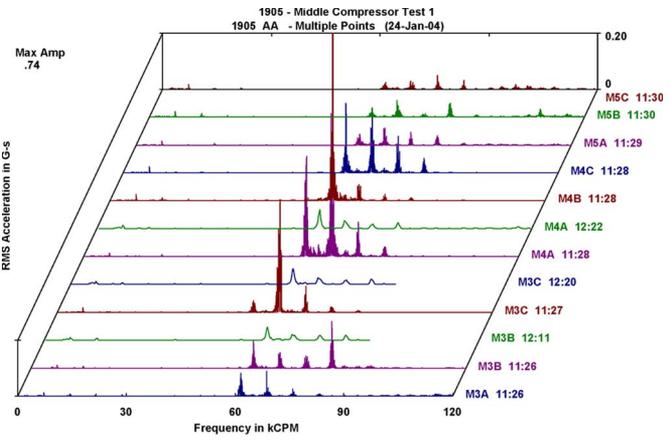
Fig. 7. Cascade plot of the vibration spectrum prior to rewedging. The cycling nature of the compressor is directly reflected in the vibration spectrums over time.

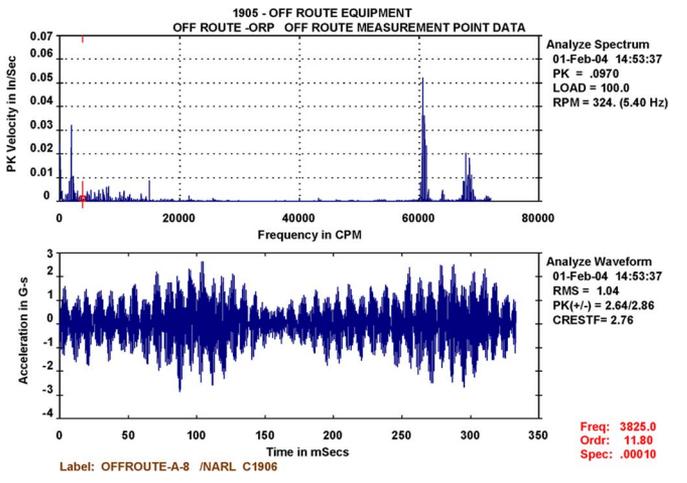
Fig. 8. Vibration spectrum on stator core, unloaded, after rewedging.

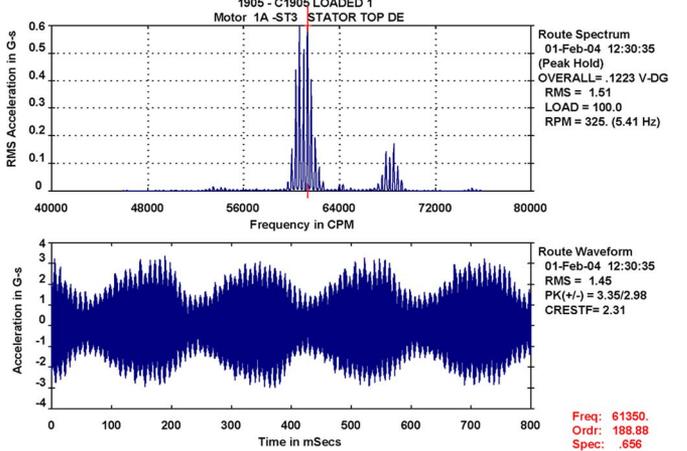
Figs. 9 and 10 show vibration of the motor loaded after rewedging. As the motor went from no-load to full load, the severity of the high-frequency vibration increased by four to five times. This high-frequency vibration is not uncommon, but on a well-designed motor, the amplitude of the high frequency is very low or nonexistent.

Fig. 9. Vibration spectrum on stator core, loaded, after rewedging. Vibration cycling is still very predominating.

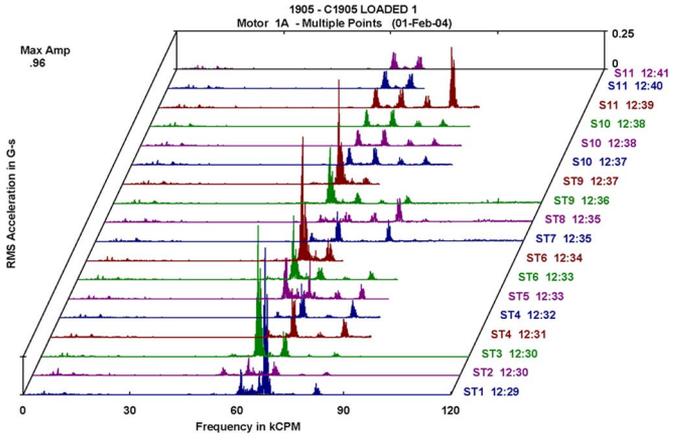
Fig. 10. Cascade of vibration spectrum on the stator core, when the motor is loaded. No change in vibration exhibited on the stator core even after rewedging.
