Mechanical and Electrical Challenges of Large Induction Motors Driving Reciprocating Compressors With Three Years Service

**Presented at the 2010 Gas Machinery Conference
Phoenix, Arizona**

Dennis W. Schmitt, PE, P.Eng.
Encana Corporation

Dr. Robert A. Hanna, Ph.D
RPM Engineering Ltd.

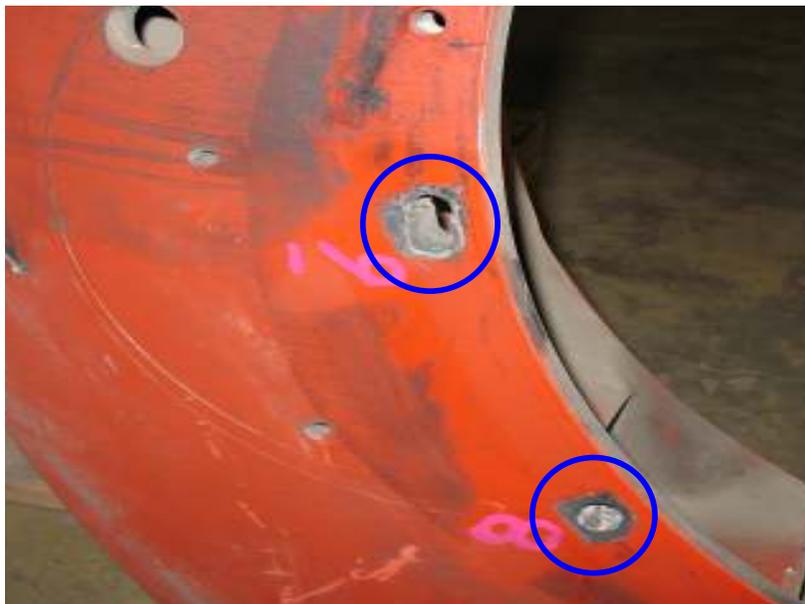
The design of the fan for this motor is a bolted joint where a cast aluminum fan is bolted to a machined steel boss that has a shrink fit onto the steel rotor shaft. In both cases, when the fan failed, many of the bolts in the assembly were sheared and the cast aluminum fan had significant damage at the bolt holes. The failure modes for the two cooling fans were essentially identical. The aluminum fan housing had many bolt holes that were 'key slotted' whereas others had no damage due to the bolt backing out completely prior to failure, see Fig. 1. There was also significant evidence of fretting corrosion on the mating surface between the fan and the steel boss indicating substantial and/or frequent relative motion, see Fig. 2.

Figure 1 One fan bolt hole damaged and another with no damage

These 1200 rpm units are started at full voltage with the compressor unloaded and, at the time of the failures, were shut down with the compressor fully loaded. These operational conditions led to very high acceleration during start up (2.5 seconds) and approximately twice the startup acceleration magnitude during shut down. This combination of inertial forces caused the fan to slip during startup and then fully reverse during shutdown. It is believed that this very small rotational translation is what led to the development of fretting corrosion. As the surface asperities grew in number and size, the effectiveness of the bolted joint decreased. Total rotational slip of the fan with respect to the fan boss likely increased. This relative motion combined with some inherent machine vibration and a low initial bolt torque ultimately allowed some of the bolts to become loose and vibrate out.

The motor manufacturer already had an 'improved' fan design that was available. This improved design used 33% more bolts with 78% more cross sectional area and included an additional steel ring as part of the improved design. This steel ring was installed on the inside of the fan which created a steel-aluminum-steel bolted joint assembly. This, in combination with more and larger bolts, increased S_f to approximately 5.

In addition to the improved design, the choice of bolt was also evaluated. The original and replacement bolts provided by the motor manufacturer were property class 4.8 (approx. SAE grade 2) which is a low strength, mild steel bolt. For the fan upgrade process, two changes were made to the bolts. Property class 8.8 (approx. SAE grade 5) bolts were selected for use and all of the bolt heads were drilled to accept stainless steel safety locking wire, see Fig. 3. Changing the bolt property class allowed the S_f to be increased yet again to approximately 8.5.

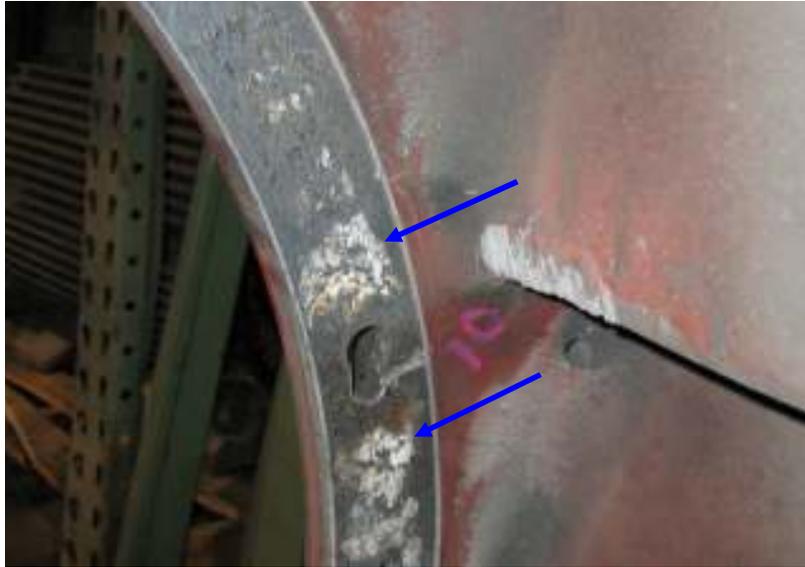
Figure 2 Fan mounting surface fretting corrosion damage

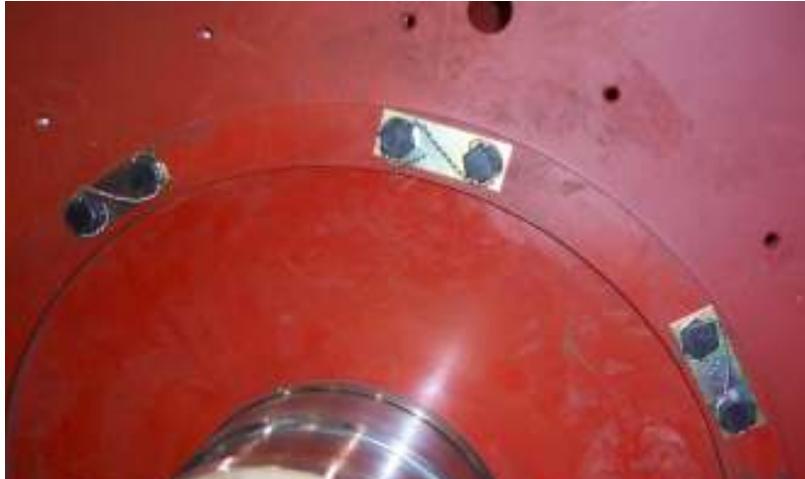
Figure 3 Example of new fan bolt layout and safety lock wire

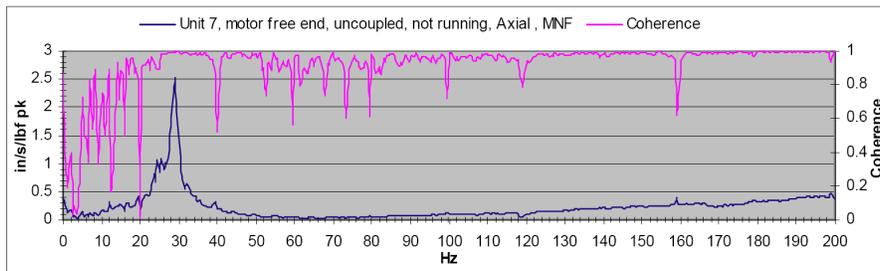
The motor MNF when uncoupled was consistently very close to 30 Hz. When the motor was coupled, running or not, the MNF was consistently between 64-68 Hz, see Fig. 4 and Fig. 5. The 3X running speed is very near to 60 Hz. Based upon the nature of the vibration amplification, as it approaches the first harmonic, it appears that there is a strong likelihood of the high axial bearing housing vibration being amplified by the mechanical natural frequency of the bearing housing and support structure itself. Mechanical modifications to the bearing housing have been investigated; however, none have been implemented to date.

Figure 4 Mechanical natural frequency of uncoupled motor, not running

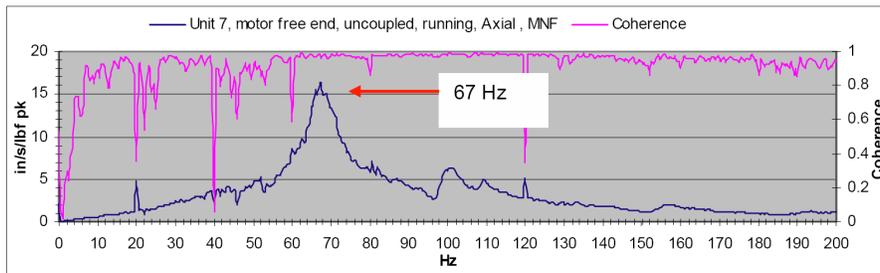
Figure 5 Mechanical natural frequency of uncoupled motor running

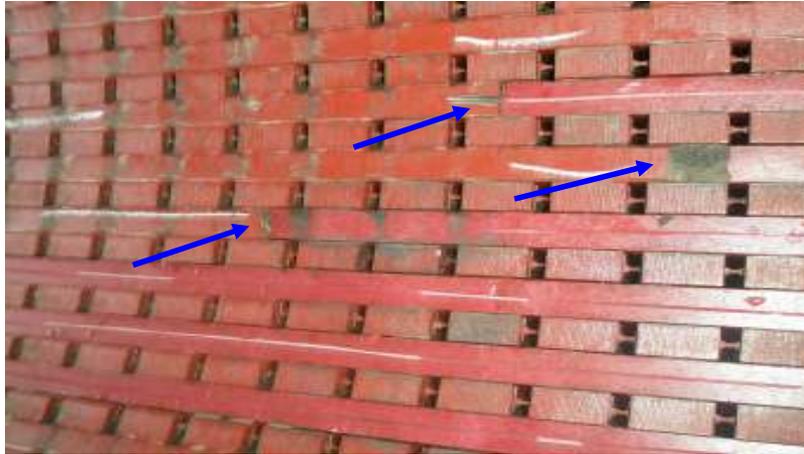
In August 2008, during a scheduled repair work to upgrade the cooling fan for the fourth 7500 HP motor from compressor station "A", it was accidentally discovered that about 50% of the magnetic wedges were either partially missing or loose, see Fig. 6. The stator has 90 slots and each slot has three magnetic wedges. The slot length is 38 1/2". The use of magnetic wedges in the stator winding widely depends upon the manufacturer's preference and their design practices. In this case, it is the motor manufacturer's common practice to use magnetic wedges for induction motors rated 7500 HP, 1200 rpm and it has been used for almost 20 years. On the other hand, motor manufacturers in North America widely use non-magnetic wedges for similar induction motor ratings. It should be noted that information regarding the type of wedges used in stator slots is not normally published, shared, or provided by any motor manufacturer at the bidding stage unless it is specifically requested or called for in the engineering specification. This information is considered detail design and privy to the manufacturer's practices.

Figure 6 Stator winding at the motor repair shop; White chalk marks identify partially damaged or loose magnetic wedges.

Several factors are attributed to the premature failure of the magnetic wedges for the 7500 HP motor at compressor station "A" with less than three years in service. These are elevated motor temperatures, excessive motor starts and high vibration. All five motors at compressor station "A" exhibited high RTD stator temperatures measured at 144° C despite running at approximately 80% rated load. Primary causes for high stator temperatures were inadequate compressor building ventilation, dusty surrounding with no motor air filters and excessive motor starts.

The repair work was carried out using magnetic wedges with the following dimensions: 5 3/8" long X 3/4" wide X 1/8" deep (see Fig. 8). The replacement magnetic wedges are half of the length of the original wedges to facilitate easier insertion at the repair shop. In this case, the total wedges to be installed were 270. The motor manufacturer approved the product technical specification for the two epoxies used by the motor repair shop for installing the new magnetic wedges. The first epoxy was applied at room temperature in the stator slots before inserting the magnetic wedges. The second product was applied over the magnetic wedges after the stator is removed from the oven. The motor was subjected to a core loss test before and after re-wedging and the results were acceptable.

Several measures were undertaken to address the factors impacting the longevity of magnetic wedges. In June 2009 the ventilation scheme for compressor building "A" was improved as that in compressor building "B". The motor enclosures were modified to install air filters with differential pressure gauges. Serious consideration is being given to installing two adjustable speed drives at compressor station "A", similar in concept to that at compressor station "B", to soft start the existing five 7500 HP.

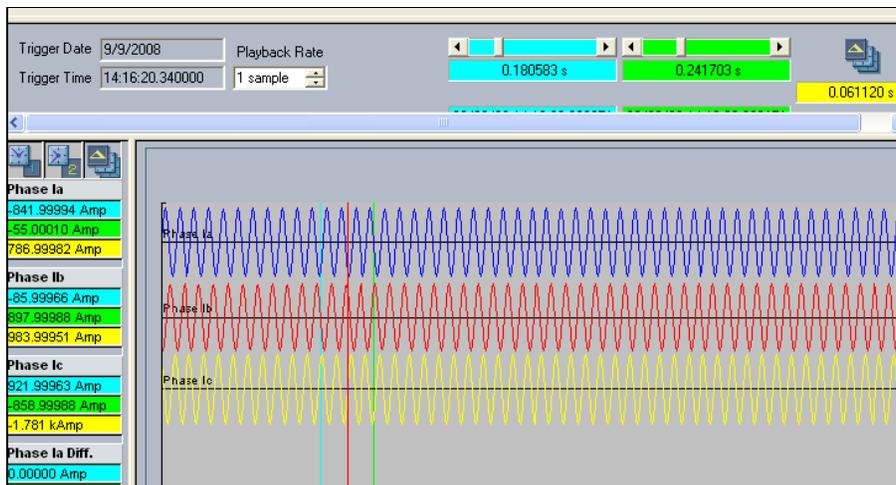
- The surrounding area to the compressor building “A” is fairly dusty and all the motors have WPII enclosures without a provision to add air filters.
- It is common that a reciprocating compressor load profile exerts greater electro-magnetic forces on the magnetic wedges due to the pulsating currents and when the motor is running at rated load. This was not a factor in this case because the stator current profile, see Fig. 7 is uniform (non-pulsating) and the motor was running at 80% load. MG1–2003 standard [3] calls for the current variation in induction motors driving a reciprocating type load not to exceed 66% of full load value. In this case, the variation between minimum and maximum current measurements was insignificant, less than 2%, well within MG1 requirements.

Figure 7 Sample of stator current waveforms for phase A, B, and C. FLA is 872 Amps rms

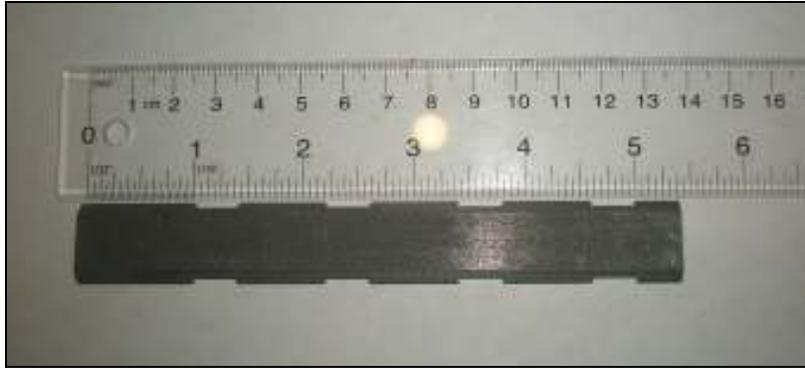
Figure 8 Sample of new magnetic wedge replacement

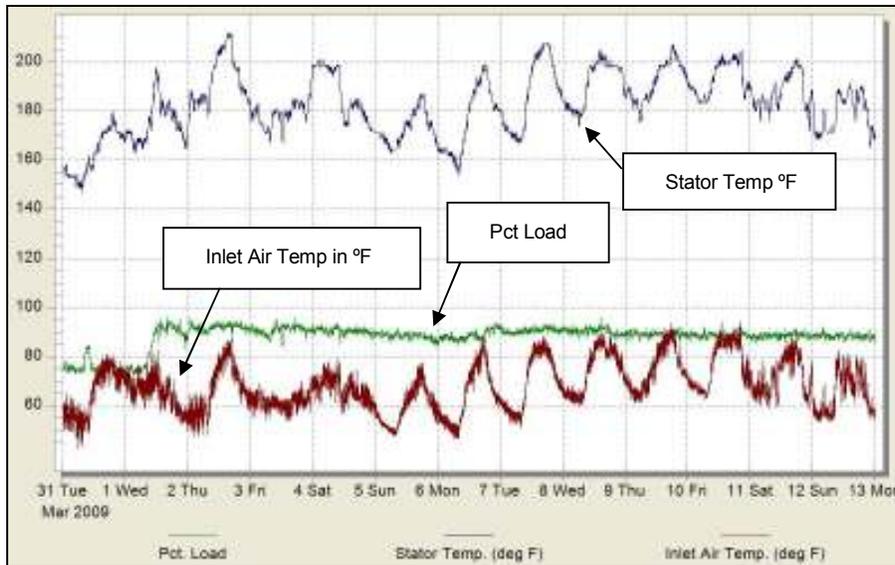
These factors were investigated and in this case the overload factor is disregarded because the motor was running at 81% rating. The ambient temperature was measured throughout the compressor building “A” in the proximity of the five compressors using an infrared temperature instrument. The measurement showed a considerable difference between the outside and inside ambient temperatures and this difference was greater in the afternoon. On the other hand, at compressor building “B”, the inside and outside ambient temperatures were close because the building is equipped with forced ventilation using several fans. The ventilation scheme that exists in compressor building “B” is very effective in cooling the compressor building. There was a close correlation between the ambient air temperature and motor temperature rise. The higher the ambient temperature adjacent to the motor, the higher was the motor stator temperature rise. Fig. 9 shows data retrieved from the distributed control system (DCS) during March 2009 for a two week period.

Figure 9 Correlation between stator and inlet temperature
