# FAILURE ANALYSIS OF INDUCTION MOTORS

Magnetic wedges in  
compression stations

**T**HIS ARTICLE PRESENTS the failure analysis and field measurements of five 7,500-hp induction motors driving reciprocating compressors for a natural gas compression station. The failure analysis examined fan design, vibration, motor-operating temperature, compressor loading profile, number of motor starts, and ambient temperature. A comparison between direct online motor starting and soft starting using an adjustable speed drive (ASD) and the impact on motor performance are presented. The settings and historical data gathered from the microprocessor protection relay for the motors are also covered and discussed.

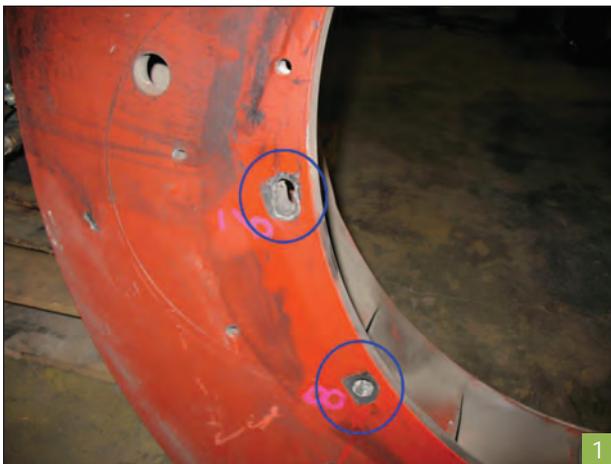
The design of the fan for this motor is a bolted joint, where a cast aluminum fan is bolted to a machined steel boss that has a shrink fit onto the steel rotor shaft. In both cases, when the fan failed, many of the bolts in the assembly were sheared, and the cast aluminum fan was damaged at the bolt holes. The failure modes for the two cooling fans were essentially identical. The aluminum fan housing had many bolt holes that were key slotted, whereas others had no damage due to the bolt backing out completely before failure (Figure 1). There was also significant evidence of fretting corrosion on the mating surface between the fan and steel boss, indicating substantial and/or frequent relative motion (Figure 2).

One damaged fan bolt hole and another with no damage.

The motor manufacturer already had an improved fan design that was available. This improved design used 33% more bolts with 78% more cross-sectional area and included an additional steel ring as part of the improved design. This steel ring was installed on inside of the fan and created a steel-aluminum-steel bolted joint assembly. This in combination with more and larger bolts increased  $S_f$  to approximately five.

In addition to the improved design, the choice of the bolt was also evaluated. The original and replacement bolts provided by the motor manufacturer were property class 4.8 (approximately SAE grade 2), which is a low-strength, mild steel bolt. For the fan upgrade process, two changes were made to the bolts. Property class 8.8 (approximately SAE grade 5) bolts were selected for use, and all of the bolt heads were drilled to fix the stainless steel safety locking wire (Figure 3). Changing the bolt property class allowed the  $S_f$  to be increased again to approximately 8.5.

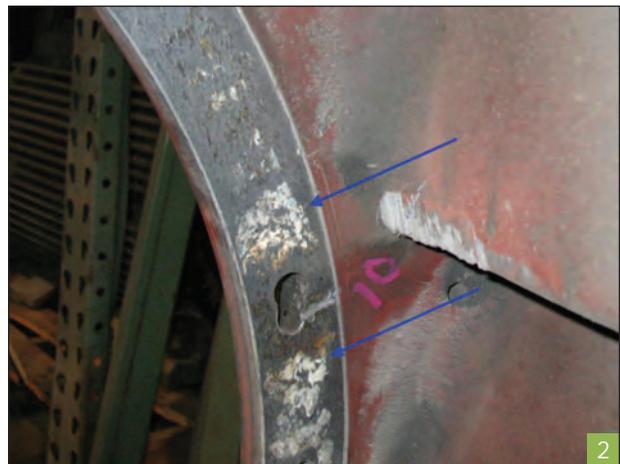
Fan-mounting surface-fretting corrosion damage.

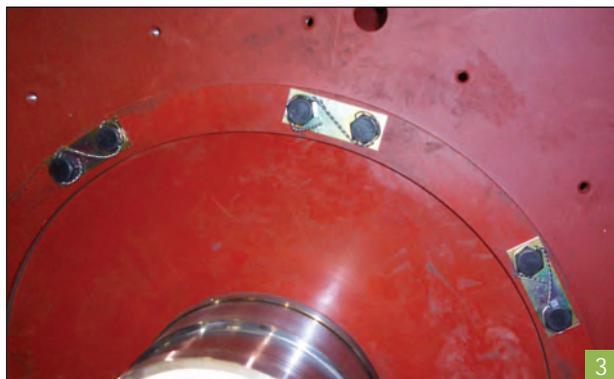
An example of a new fan bolt layout and a safety lock wire.

As part of the fan-replacement process, all fans have been upgraded to the manufacturer's improved design, and all motors (at both compressor stations) have had property class 8.8 bolts installed with safety-lock-wired heads. To date, there have been no additional fan failures.

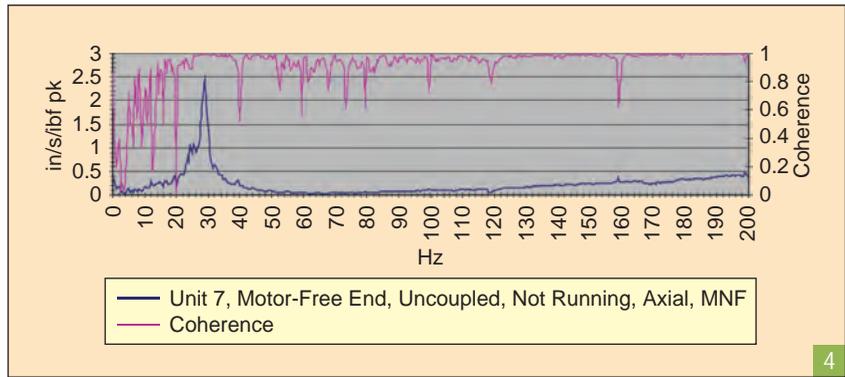
When uncoupled, the motor MNF was consistently very close to 30 Hz. When the motor was coupled, running or not, the MNF was consistently between 64 and 68 Hz (Figures 4 and 5). The running speed tripled and was close to 60 Hz. Based on the nature of vibration amplification, as it approaches the first harmonic, there is a strong likelihood that the high axial bearing housing vibration is being amplified by the MNF of the bearing housing and support structure itself. Mechanical modifications to the bearing housing have been investigated; however, none have been implemented to date.

An MNF of uncoupled motor, not running.

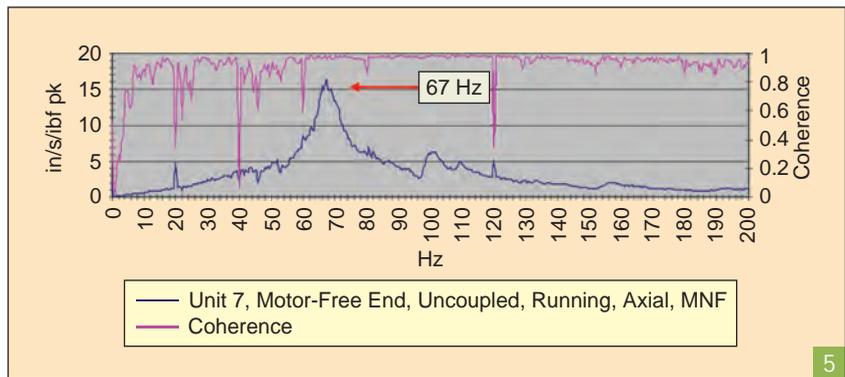
An MNF of uncoupled motor running.

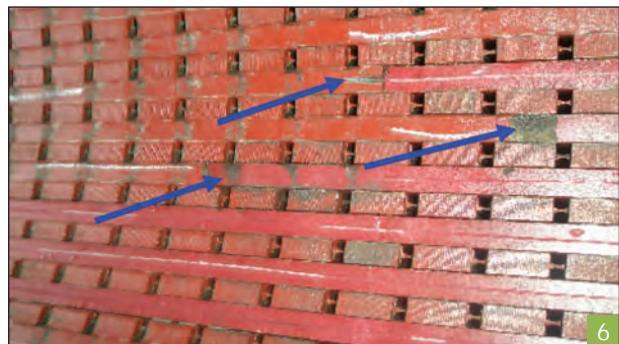
In August 2008, during scheduled repair work to upgrade the cooling fan for the fourth 7,500-hp motor from compressor station A, it was accidentally discovered that about 50% of the magnetic wedges were either partially missing or loose (Figure 6). The stator has 90 slots, and each slot has three magnetic wedges. The slot length is 38 1/2 in. The use of magnetic wedges in the stator winding widely depends on the manufacturer's preference and their design practices. In this case, the motor manufacturer generally uses magnetic wedges for induction motors rated 7,500 hp and 1,200 r/min, and this practice has been followed for almost 20 years. It should be

Stator winding at the motor repair shop. White chalk marks identify partially damaged or loose magnetic wedges.

Several factors are attributed to the premature failure of magnetic wedges for the 7,500-hp motor at compressor station A with less than three years of service. These are elevated motor temperatures, excessive motor starts, and high vibration. All five motors at compressor station A exhibited high RTD stator temperatures measured at  $144\text{ }^{\circ}\text{C}$ , despite running at approximately 80% rated load. Primary causes for high stator temperatures were inadequate compressor building ventilation, dusty surrounding with no motor air filters, and excessive motor starts.

The repair work was carried out using magnetic wedges with the following dimensions: 5 3/8 in long × 3/4 in

wide × 1/8 in deep (Figure 8). The replacement magnetic wedges were half the length of the original wedges to facilitate easier insertion at the repair shop. Here, the total number of wedges that were installed was 270. The motor manufacturer approved the product technical specification for the two epoxies used by the motor repair shop for installing the new magnetic wedges. The first epoxy was applied at room temperature in the stator slots before inserting the magnetic wedges. The second product was applied over the magnetic wedges after the stator is removed from the oven. The motor was subjected to a core loss test before and after rewinding, and the results were acceptable.

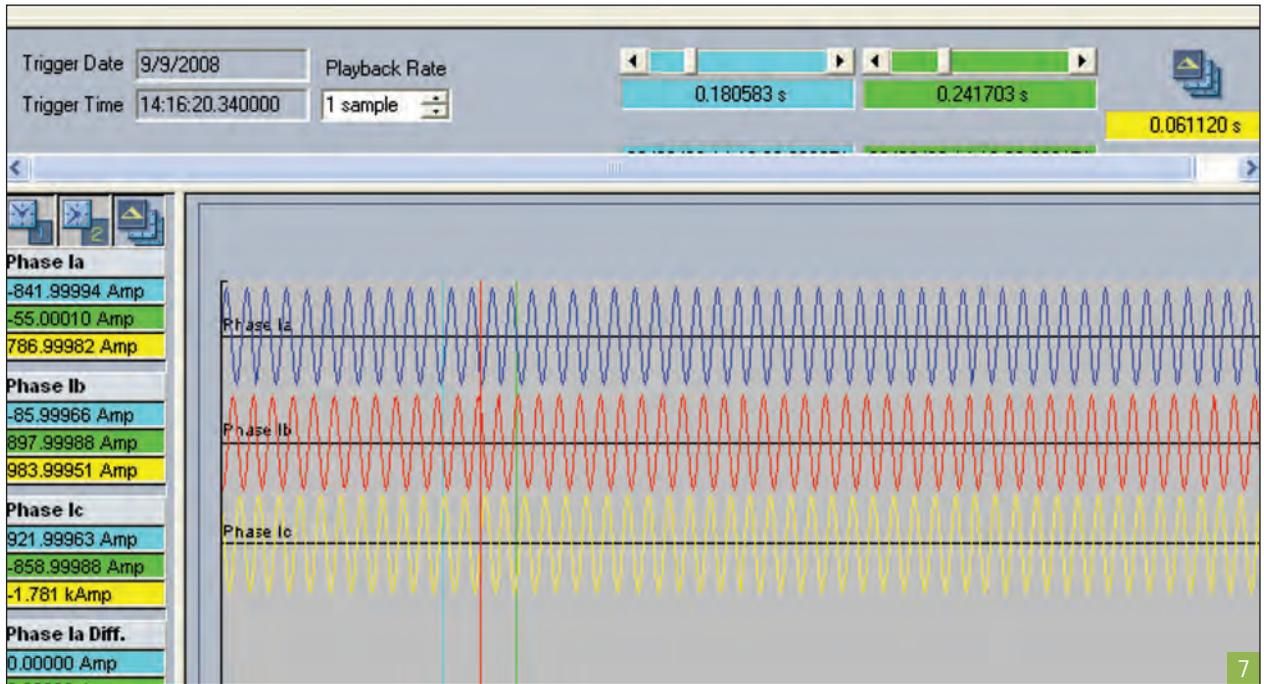
- It is common that a reciprocating compressor load profile exerts greater electromechanical forces on the magnetic wedges due to the pulsating currents and the motor being run at a rated load. This was not a factor in this case because the stator current profile (Figure 7) is uniform (nonpulsating) and the motor was running at 80% load. MG1-2003 standard [3] calls for the current variation in induction motors driving a reciprocating-type load not to exceed 66% of full load value. In this case, the variation between minimum and maximum current measurements was insignificant, less than 2%, well within MG1 requirements.

Sample of stator current waveforms for phases A–C. FLA is 872 Arms.

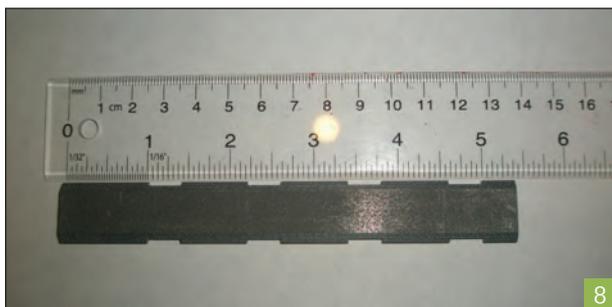
Sample of new magnetic wedge replacement.

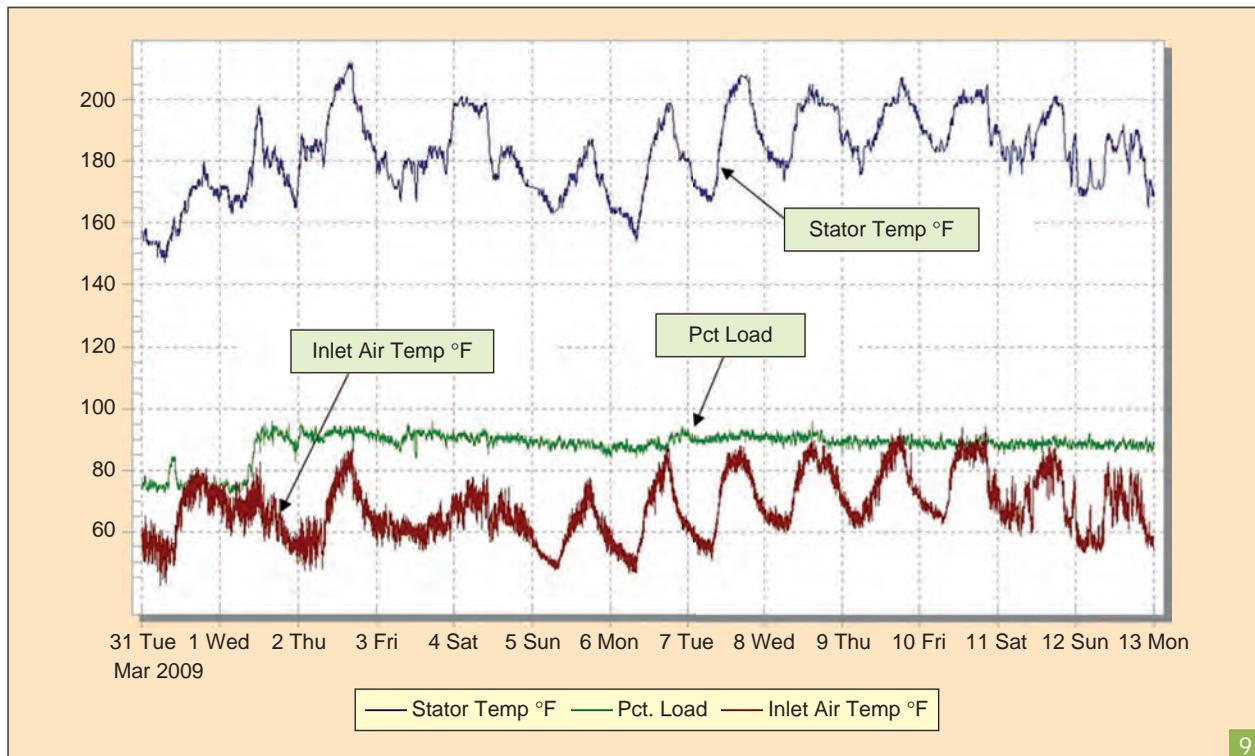
ity of five compressors using an infrared temperature instrument. The measurement showed a considerable difference between the outside and inside ambient temperatures, and this difference was greater in the afternoon. On the other hand, at compressor building B, the inside and outside ambient temperatures were close because the building is equipped with forced ventilation using several fans. The ventilation scheme that exists in compressor building B was very effective in cooling the building. There was a close correlation between the ambient air temperature and motor temperature rise. The higher the ambient temperature adjacent to the motor, the higher was the motor stator temperature rise. Figure 9 shows data

Correlation between stator and inlet temperature.

Many measures were undertaken to address the factors impacting the longevity of magnetic wedges. In June 2009, the ventilation scheme for

compressor building A was improved similar to that in compressor building B. The motor enclosures were modified to install air filters with differential pressure gauges. Serious consideration was given to install two ASDs at compressor station A, similar in concept to that at compressor station B, to soft start the existing five 7,500 hp.
