# Failure Analysis of 7500 HP Induction Motors Driving Reciprocating Compressors with Three Years Service

Copyright Material IEEE  
Paper No. PCIC-2010-30

**Abstract** – This paper presents the failure analysis and field measurements of five 7500 HP induction motors driving reciprocating compressors for a natural gas compression station. The motors were in service for less than three years when two of them suffered cooling fan failures. Four of the five motors were individually sent one at a time to a motor repair shop to be fitted with a modified cooling fan per the manufacturer's recommendation. It was during one of the fan replacement processes that the repair shop, accidentally, discovered that many of the magnetic wedges were missing. The end user is not always aware if a motor is provided with magnetic or non-magnetic wedges unless identified in the motor engineering specification.

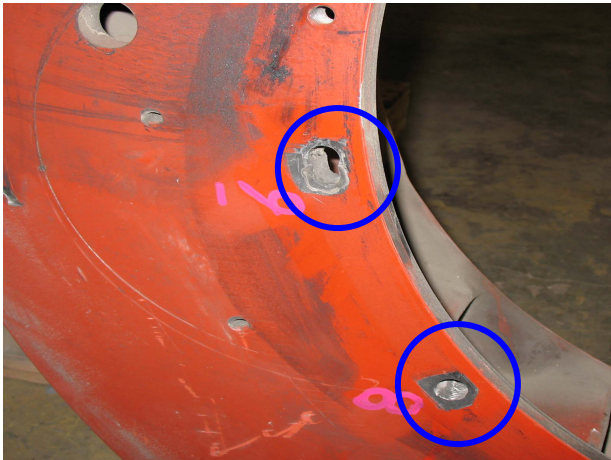
The design of the fan for this motor is a bolted joint where a cast aluminum fan is bolted to a machined steel boss that has a shrink fit onto the steel rotor shaft. In both cases, when the fan failed, many of the bolts in the assembly were sheared and the cast aluminum fan had significant damage at the bolt holes. The failure modes for the two cooling fans were essentially identical. The aluminum fan housing had many bolt holes that were 'key slotted' whereas others had no damage

due to the bolt backing out completely prior to failure, see Fig. 1. There was also significant evidence of fretting corrosion on the mating surface between the fan and the steel boss indicating substantial and/or frequent relative motion, see Fig. 2.

Fig. 1 One fan bolt hole damaged and another with no damage

These 1200 rpm units are started at full voltage with the compressor unloaded and, at the time of the failures, were shut down with the compressor fully loaded. These operational conditions led to very high acceleration during start up (2.5 seconds) and approximately twice the startup acceleration magnitude during shut down. This combination of inertial forces caused the fan to slip during startup and then fully reverse during shutdown. It is believed that this very small rotational translation is what led to the development of fretting corrosion. As the surface asperities grew in number and size, the effectiveness of the bolted joint decreased. Total rotational slip of the fan with respect to the fan boss likely increased. This relative motion combined with some inherent machine vibration and a low initial bolt torque ultimately allowed some of the bolts to become loose and vibrate out.

The motor manufacturer already had an 'improved' fan design that was available. This improved design used 33% more bolts with 78% more cross sectional area and included an additional steel ring as part of the improved design. This steel ring was installed on the inside of the fan which created a steel-aluminum-steel bolted joint assembly. This, in combination with more and larger bolts, increased  $S_f$  to approximately 5.

In addition to the improved design, the choice of bolt was also evaluated. The original and replacement bolts provided by the motor manufacturer were property class 4.8 (approx. SAE grade 2) which is a low strength, mild steel bolt. For the fan upgrade process, two changes were made to the bolts. Property class 8.8 (approx. SAE grade 5) bolts were selected for use and all of the bolt heads were drilled to accept stainless steel safety locking wire, see Fig. 3. Changing the bolt property class allowed the  $S_f$  to be increased yet again to approximately 8.5.

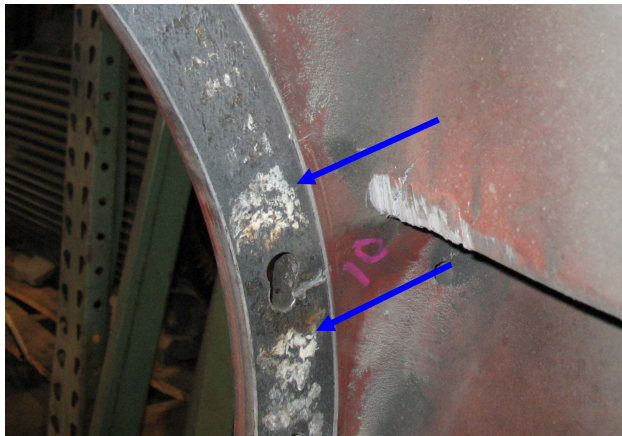
Fig. 2 Fan mounting surface fretting corrosion damage

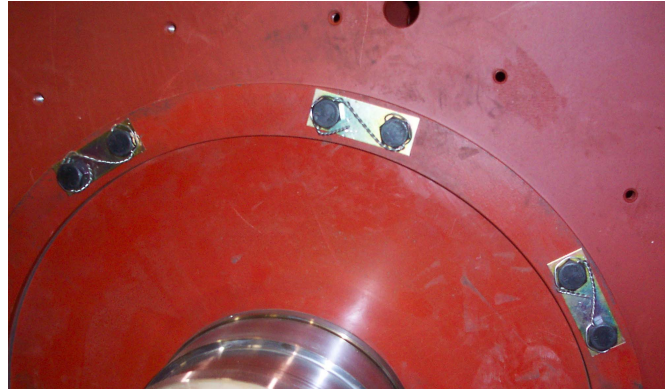
Fig. 3 Example of new fan bolt layout and safety lock wire

As part of the fan replacement process, all fans have been upgraded to the manufacturer's improved design and all motors (at both compressor stations) have had property class 8.8 bolts installed with safety lock wired heads. To date, there have been no additional fan failures.

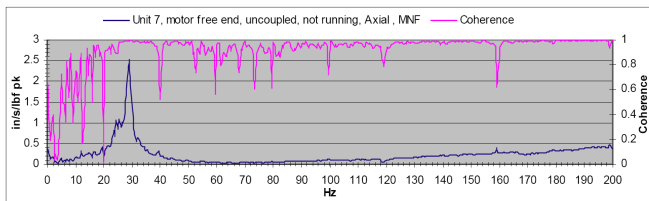
The motor MNF when uncoupled was consistently very close to 30 Hz. When the motor was coupled, running or not, the MNF was consistently between 64-68 Hz, see Fig. 4 and Fig. 5. The 3X running speed is very near to 60 Hz. Based upon the nature of the vibration amplification, as it approaches the first harmonic, it appears that there is a strong likelihood of the high axial bearing housing vibration being amplified by the mechanical natural frequency of the bearing housing and support structure itself. Mechanical modifications to the bearing housing have been investigated; however, none have been implemented to date.

Fig. 4 Mechanical natural frequency of uncoupled motor, not running

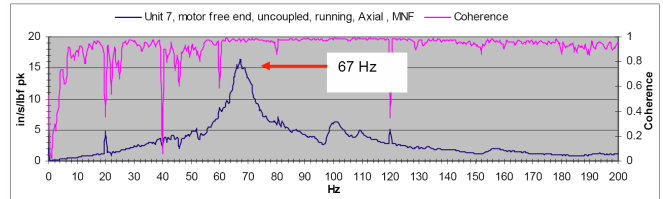
Fig. 5 Mechanical natural frequency of uncoupled motor running

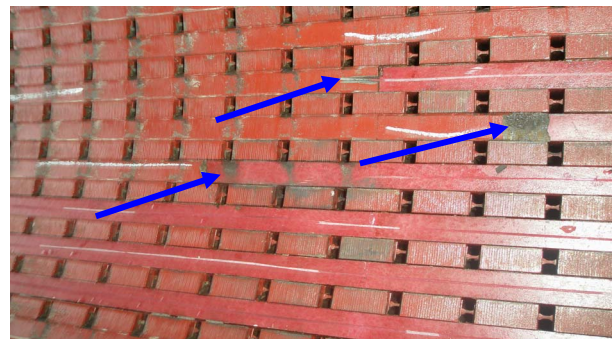
In August 2008, during a scheduled repair work to upgrade the cooling fan for the fourth 7500 HP motor from compressor station “A”, it was accidentally discovered that about 50% of the magnetic wedges were either partially missing or loose, see Fig. 6. The stator has 90 slots and each slot has three magnetic wedges. The slot length is 38 1/2”. The use of magnetic wedges in the stator winding widely depends upon the manufacturer’s preference and their design practices. In this case, it is the motor manufacturer’s common practice to use magnetic wedges for induction motors rated 7500 HP, 1200 rpm and it has been used for almost 20 years. On the other hand, motor manufacturers in North America widely use non-magnetic wedges for similar induction motor ratings. It should be noted that information regarding the type of wedges used in stator slots is not normally published, shared, or provided by any motor manufacturer at the bidding stage unless it is specifically requested or called for in the engineering specification. This information is considered detail design and privy to the manufacturer’s practices.

Fig. 6: Stator winding at the motor repair shop. White chalk

marks identify partially damaged or loose magnetic wedges.

A typical magnetic wedge material comprises of 75% iron powder, 7% glass mat and 18% epoxy resin. Magnetic wedges are more susceptible to failure when compared to non-magnetic wedges because they are more brittle due to the high percentage of iron powder. In addition, for reciprocating type loads, the magnetic wedges by their very nature are subject to cyclic mechanical forces (120 times per second) so that if there is any freedom to move in the stator slot, fretting can occur and the movement will slowly increase until wedge failure occurs. Upon failure, magnetic wedges normally disintegrate into very small pieces and get crushed in the very small air-gap (2.8 mm) between the stator and rotor. Typically, upon failure, magnetic wedges leave a distinct color mark on the rotor surface. The reliability and longevity of magnetic wedges are greatly impacted by the following factors:

The repair work was carried out using magnetic wedges with the following dimensions: 5 3/8" long X 3/4" wide X 1/8" deep (see Fig. 8). The replacement magnetic wedges are half of the length of the original wedges to facilitate easier insertion at the repair shop. In this case, the total wedges to be installed were 270. The motor manufacturer approved the product technical specification for the two epoxies used by the motor repair shop for installing the new magnetic wedges. The first epoxy was applied at room temperature in the stator slots before inserting the magnetic wedges. The second product was applied over the magnetic wedges after the stator is removed from the oven. The motor was subjected to a core loss test before and after re-wedging and the results were acceptable.

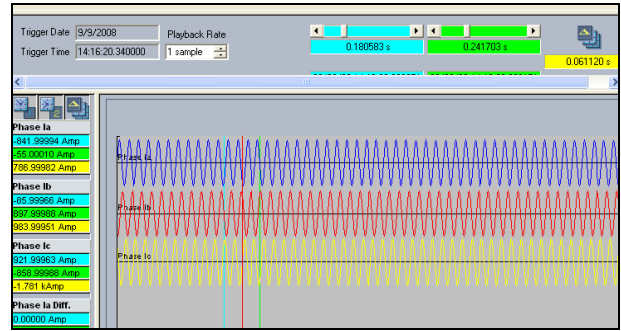
- The surrounding area to the compressor building "A" is fairly dusty and all the motors have WP11 enclosures without a provision to add air filters.
- It is common that a reciprocating compressor load profile exerts greater electro-magnetic forces on the magnetic wedges due to the pulsating currents and when the motor is running at rated load. This was not a factor in this case because the stator current profile, see Fig. 7 is uniform (non-pulsating) and the motor was running at 80% load. MG1-2003 standard [3] calls for the current variation in induction motors driving a reciprocating type load not to exceed 66% of full load value. In this case, the variation between minimum and maximum current measurements was insignificant, less than 2%, well within MG1 requirements.

Fig. 7: Sample of stator current waveforms for phase A, B and C. FLA is 872 A rms.

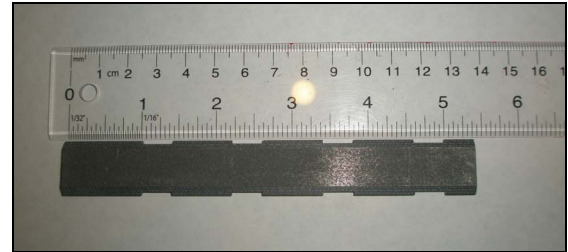
Fig. 8: Sample of new magnetic wedge replacement.

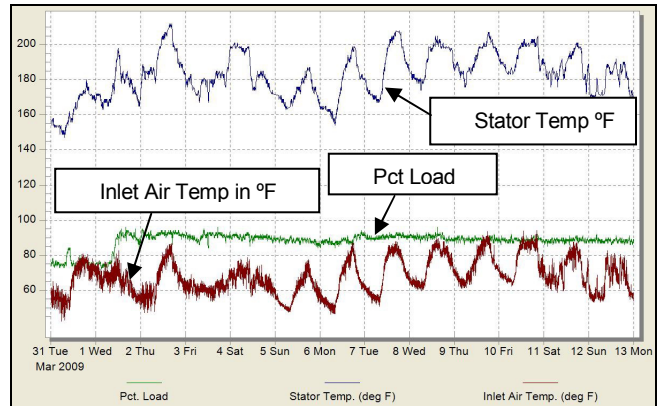
These factors were investigated and in this case the overload factor is disregarded because the motor was running at 81% rating. The ambient temperature was measured throughout the compressor building "A" in the proximity of the five compressors using an infrared temperature instrument. The measurement showed a considerable difference between the outside and inside ambient temperatures and this difference was greater in the afternoon. On the other hand, at compressor building "B", the inside and outside ambient temperatures were close because the building is equipped with forced ventilation using several fans. The ventilation scheme that exists in compressor building "B" is very effective in cooling the compressor building. There was a close correlation between the ambient air temperature and motor temperature rise. The higher the ambient temperature adjacent

to the motor, the higher was the motor stator temperature rise. Fig. 9 shows data retrieved from the distributed control system (DCS) during March 2009 for a two week period.

Fig. 9: Correlation between stator and inlet temperature

Several measures were undertaken to address the factors impacting the longevity of magnetic wedges. In June 2009 the ventilation scheme for compressor building "A" was improved as that in compressor building "B". The motor enclosures were modified to install air filters with differential pressure gauges. Serious consideration is being given to installing two adjustable speed drives at compressor station "A", similar in concept to that at compressor station "B", to soft start the existing five 7500 HP.
