Failure Analysis of Three Slow-Speed Induction Motors for Reciprocating Load Application

Abstract—The North Atlantic Refinery has three 5400-hp slow-speed induction motors driving reciprocating compressors for a Hydrogen plant. All motors were rewound on-site over the period of 1998–2002, using magnetic wedges as per the original design, and the motor protection was upgraded to microprocessor-type relays. In summer 2003, during routine maintenance, it was noted that these motors suffered substantial loss of slot magnetic wedges and had to be scheduled for rewedging over 2004–2006. This paper presents failure analysis, field measurements covering heat-run test results, and motor-performance and vibration analysis before and after motor rewedging work. This paper reviews the key factors for using magnetic versus nonmagnetic wedges in these applications and techniques available to predict loss of wedges. The use of a microprocessor relay for slow-speed induction motor protection is discussed, particularly, the thermal protection feature to address the cyclic-load pattern caused by the reciprocating compressor.

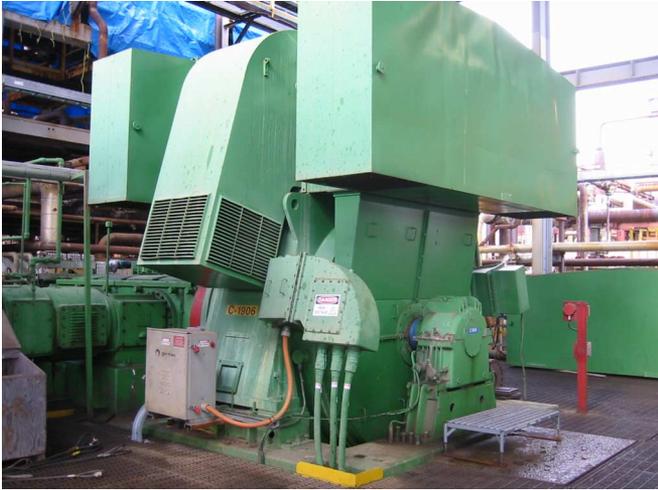
Fig. 1. 5400-hp motor overview.

group B and D areas, and the compressor shelter is open on all four sides. Fig. 1 shows a motor overview.
